3.2.1 Asphalt Shingles

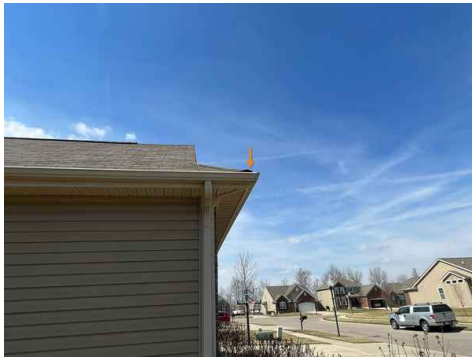
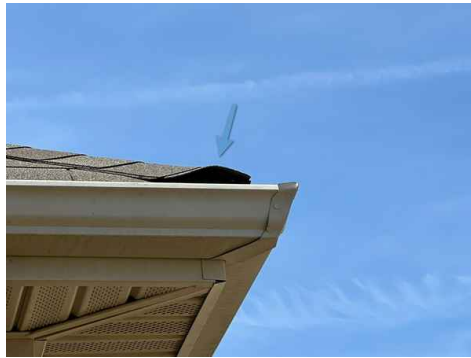
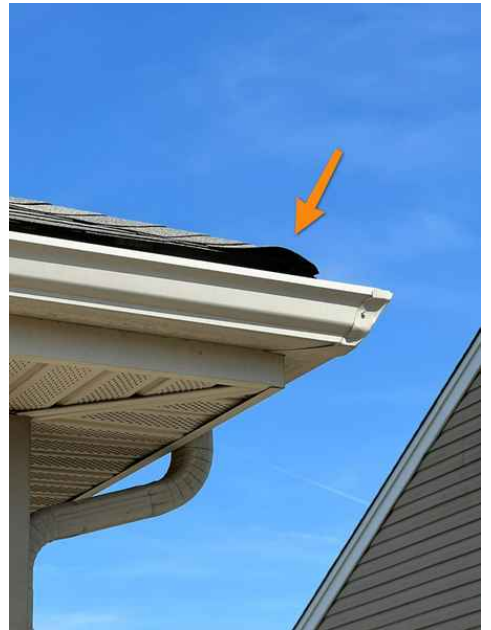
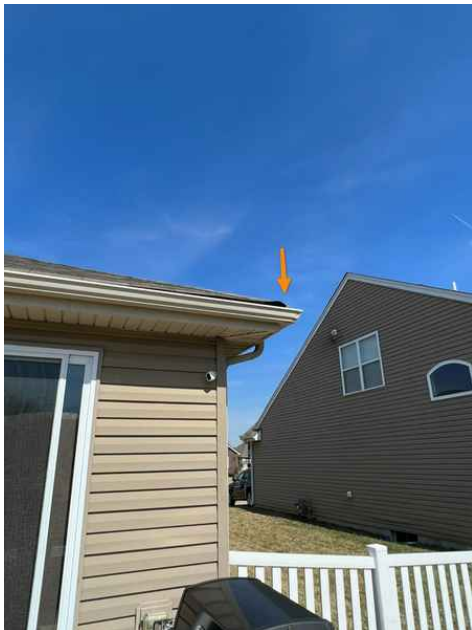
**SHINGLES BUCKLED/CURLED**

Asphalt shingles were buckled and curled in multiple locations. This is an indication that the roof covering is at or near the end of its life recommend monitoring roof covering for loose or damaged shingles in the near future.

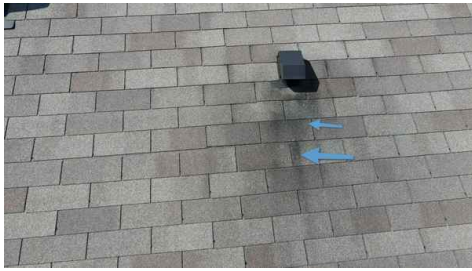
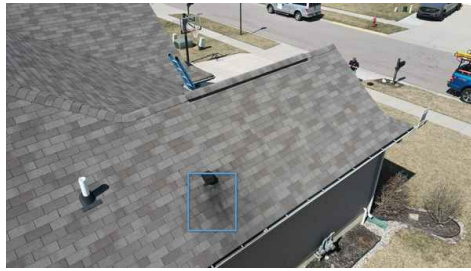
### DISCOLORATION

Roof shingles were discolored, which can be caused by moisture, rust or soot. Recommend a qualified roofing contractor evaluate and remedy with a roof cleaning or repair.

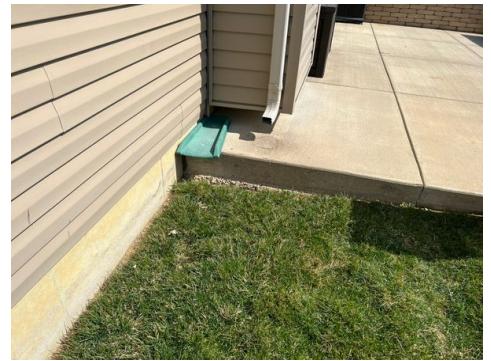
#### DOWNSPOUTS DRAIN NEAR HOUSE

One or more downspouts drain too close to the home's foundation. This can result in excessive moisture in the soil at the foundation, which can lead to foundation/structural movement. Recommend a qualified contractor adjust downspout extensions to drain at least 6 feet from the foundation.

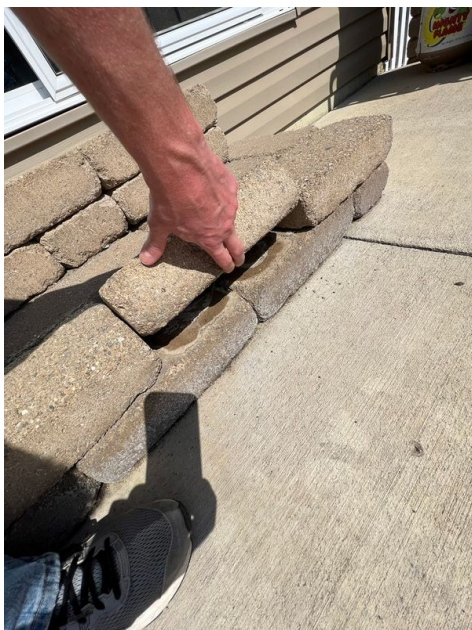
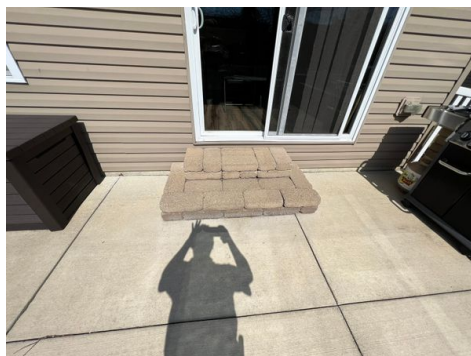
#### STEPS/ STOOPS ARE CRACKED/ DETERIORATED -REPAIR

The steps and/or stoop were loose/ deteriorated at the rear sliding glass door. Recommend repairs be made by a qualified licensed contractor.

Recommendation  
Contact a qualified professional.

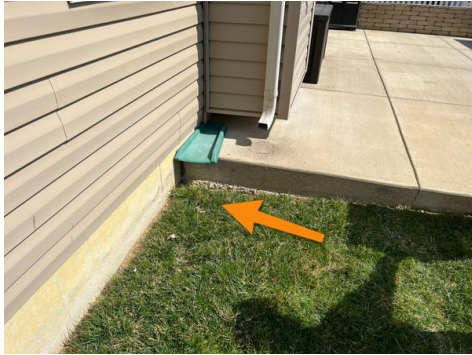
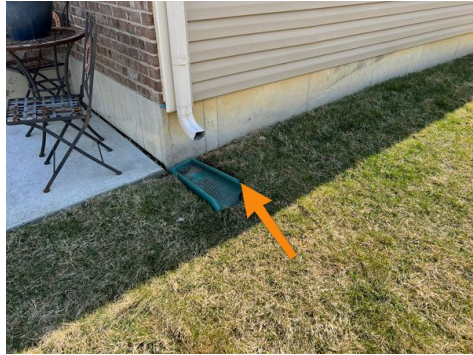
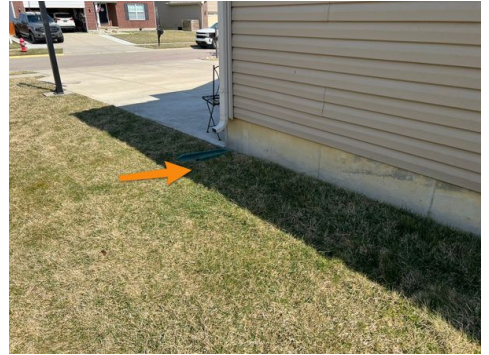
### GRADE NEGATIVE SLOPE TOWARDS THE HOME

The grade of the ground was a negative slope towards the home. Recommend installing a drainage system such as a catch basin or yard drain to remove excess water away from the foundation.

Contact a qualified professional.

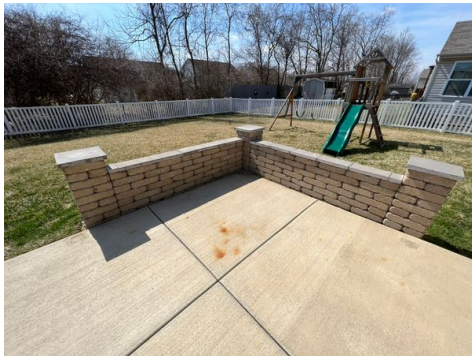
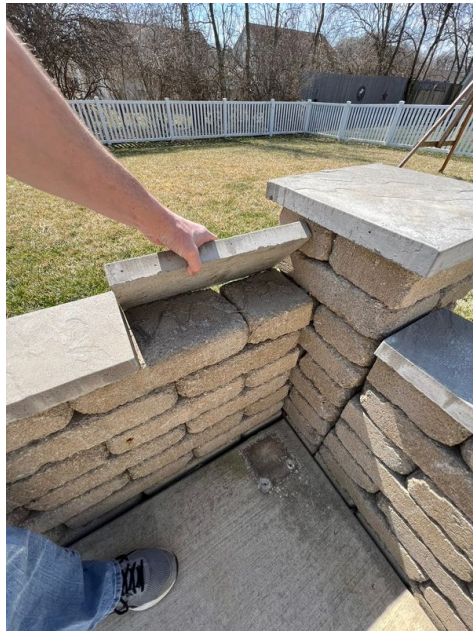
### RETAINING WALL DAMAGED

Retaining wall is showing signs of failing. Damaged materials and shifting was observed. Recommend qualified contractor evaluate and repair.

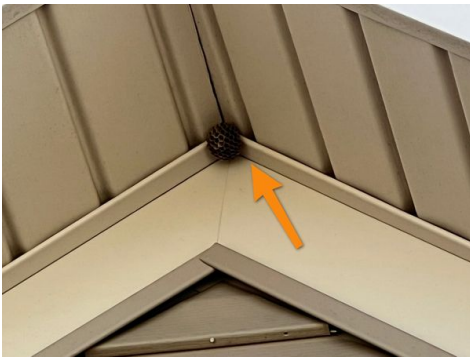
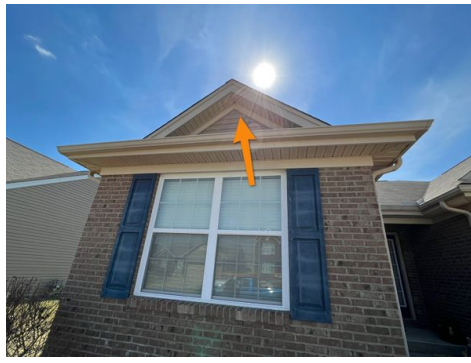
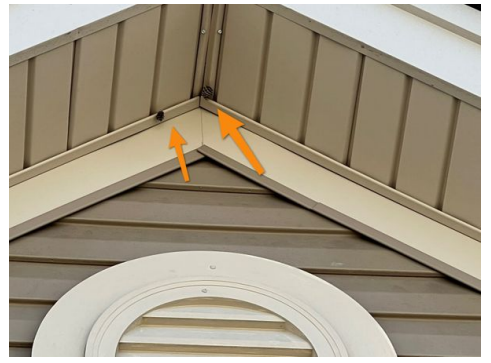
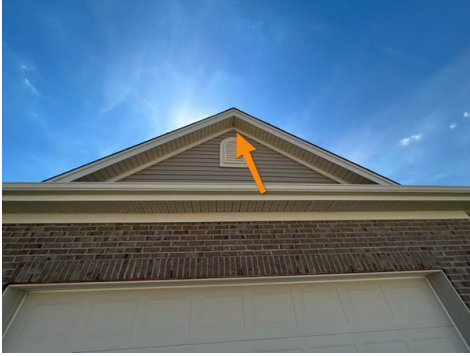
### WASPS NEST

Wasp nests were visible under the soffits. Recommend a qualified exterminator evaluate and remove.

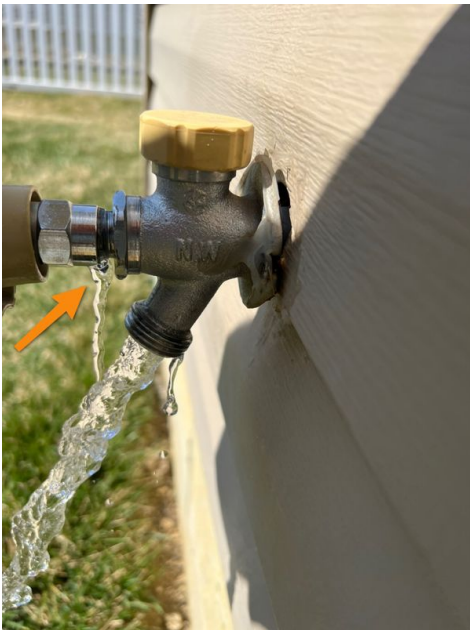
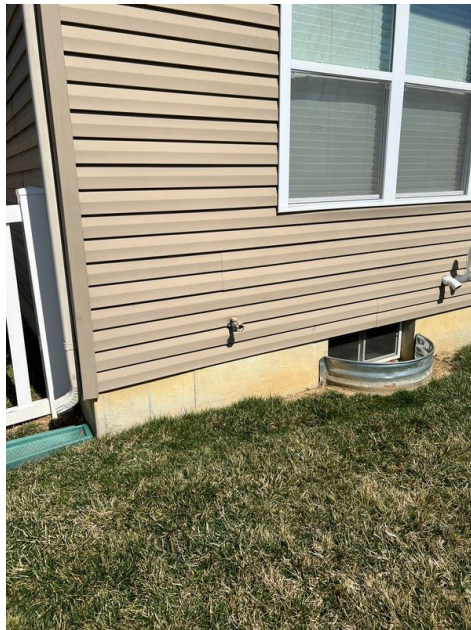
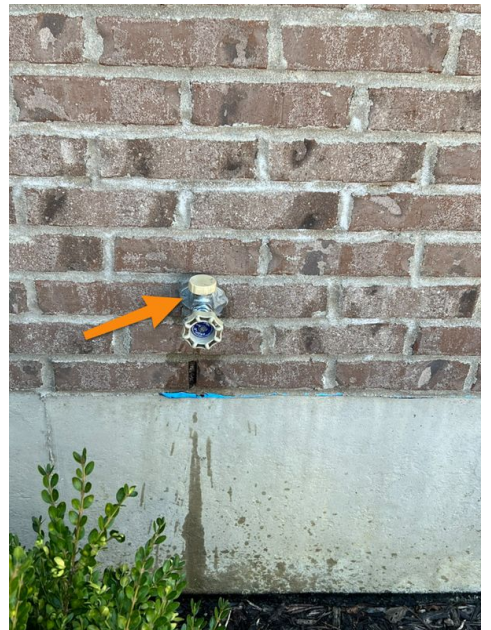
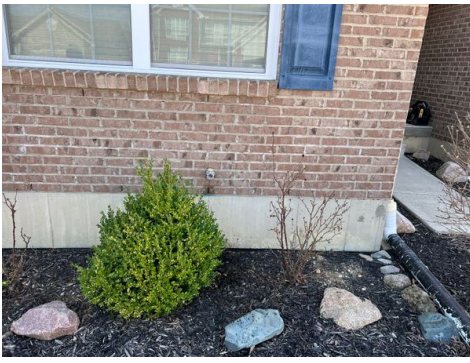
### 5.6.1 Plumbing **HOSE BIB LEAKING**

The hose bib was leaking at the time of the inspection. The bib on the front of the house is leaking from the frost resistant air valve likely due a faulty gasket. Bib on rear of house has a leaking handle. Recomend a qualified professional evaluate and repair as necessary.

Recommendation  
Contact a qualified professional.

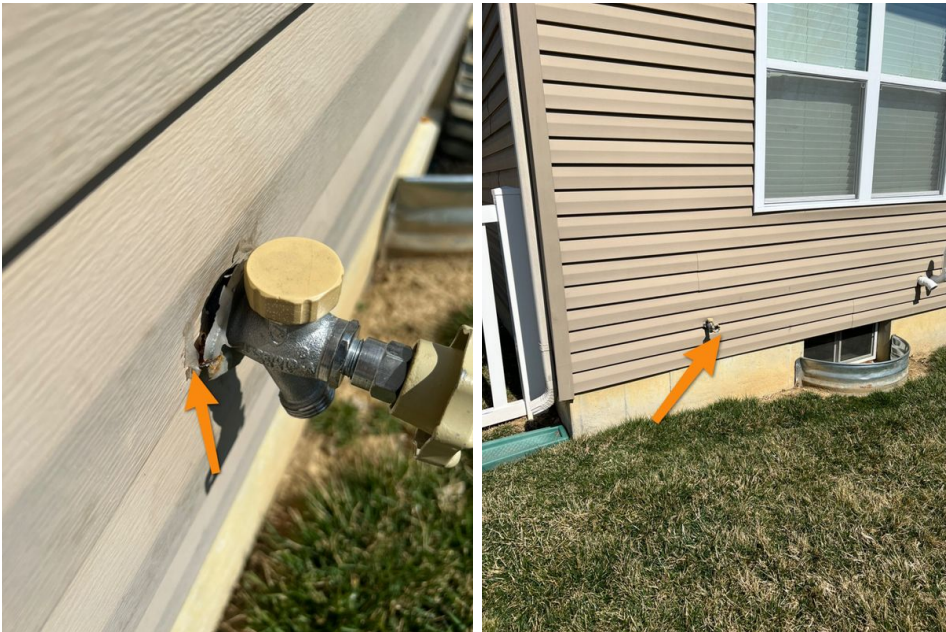
### HOSE BIB LOOSE

The hose bib was not secured properly at the time of the inspection. This type of plumbing is not designed to be able to be moved this may cause leaks in the future. Recommend a qualified plumber secure hose bib to the side of the house.

Contact a qualified professional.

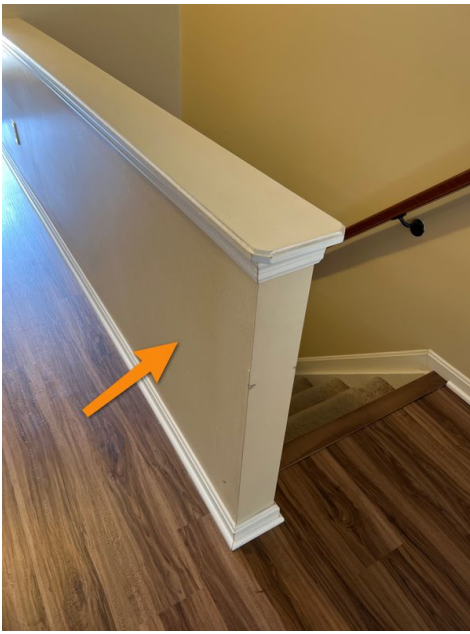
### KNEE WALL LOOSE

At the time of inspection the knee wall on the left-hand side of the stairs leading to the basement appeared loose and moved under lightweight. These new walls aid in protecting persons from Miss stepping and falling downstairs. Knee walls and Railings should be capable of supporting 500 pounds of lateral movement. Recommend a qualified contractor evaluate and repair knee wall as needed.

Contact a qualified professional.

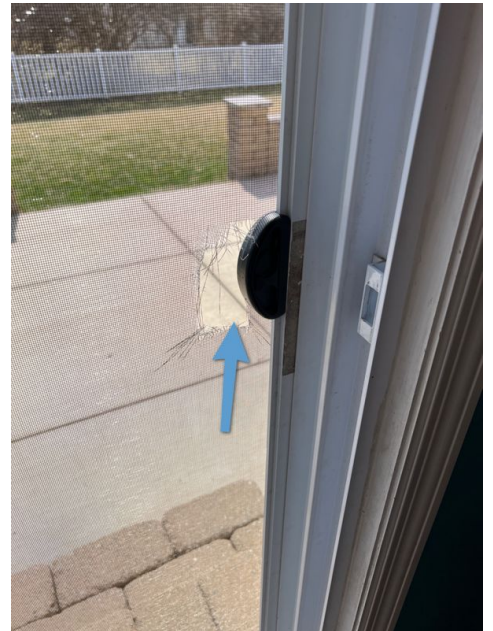
### SCREENS DAMAGED

screen door were damaged or deteriorated. These window(s) may not provide ventilation during months when insects are active. Recommend replacing window screens as necessary.

Contact a qualified window repair/installation contractor.

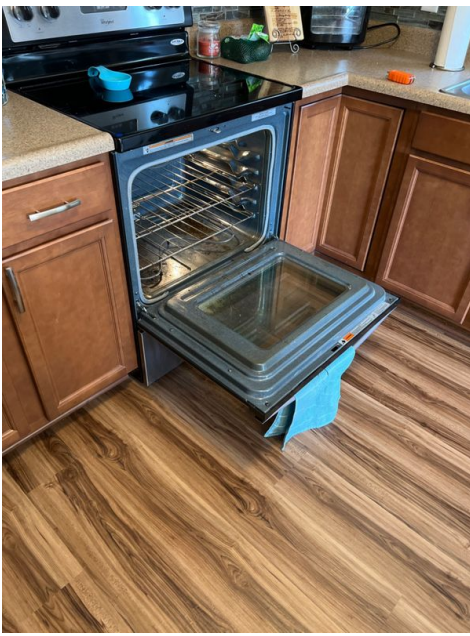
### OVEN DOOR MALFUNCTIONED - FALLS OPEN AND/OR DOES NOT FULLY CLOSE

The oven door springs and/or stops malfunctioned. The door should not fall open quickly, and it should stop securely in a horizontal position and it should fully close. Recommend that a qualified appliance repair person repair as necessary.

Contact a qualified appliance repair professional.

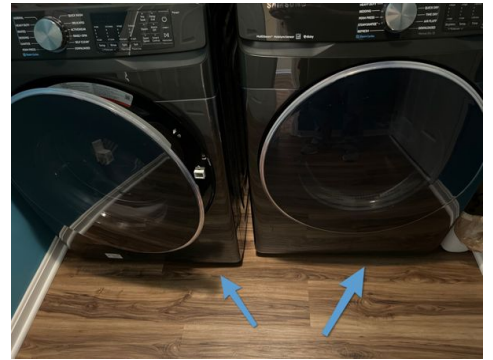
#### **NO CATCH PAN**

A clothes washer was or can be installed over a finished space or in an area where leaking can cause damage, and no catch pan or drain was installed. Catch pans and drains prevent water damage to finished interior spaces below if or when the washing machine leaks, overflows or is drained. If concerned, consult with a qualified contractor about installing a catch pan. Note that installing a drain line for a catch pan routed to the outdoors may not be feasible. As an alternative, a water alarm can be installed in the catch pan.

Contact a qualified professional.

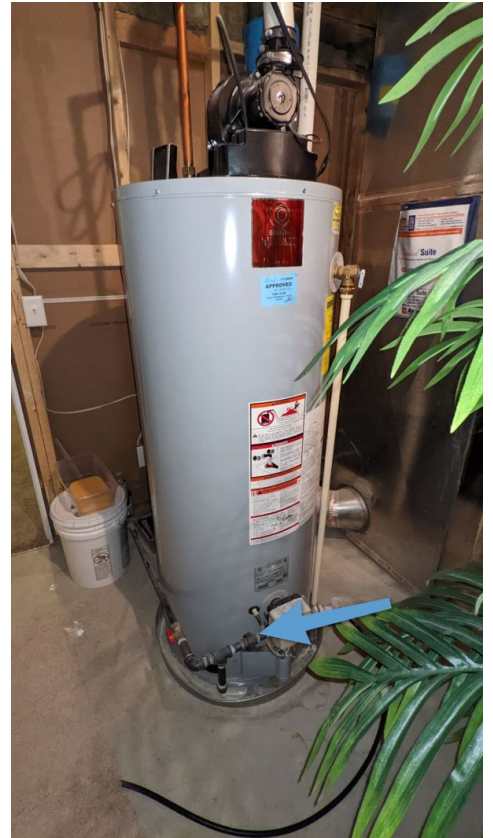
**CRACKING AND POPPING NOISE IN WATER HEATER**

Cracking and popping noise was heard in the hot water heater while the hot water heater was Heating. This is common in areas with hard water. This noise is caused from calcium buildup and other debris inside the water tank. Water heaters should be drained on a yearly basis to prevent the buildup of debris inside the tank. This is a sign of the hot water heater getting close to the end of its useful lifespan. Recommend budgeting for replacement in the near future.

Contact a qualified professional.
